WATER SYSTEM TECHNICAL AUDIT

**CITY OF PARIS
BOURBON COUNTY, KENTUCKY**

November 2020

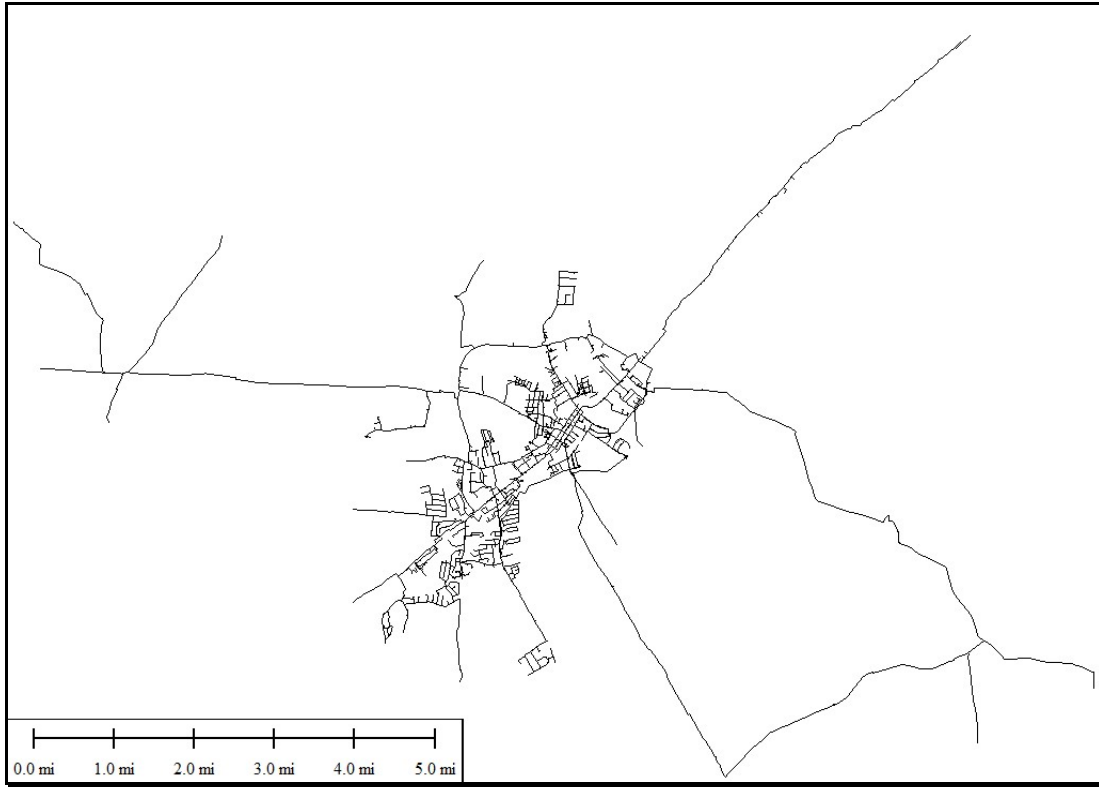
Figure 2.1: System Map

The system map shows the densely packed cast iron and ductile iron lines in downtown Paris and the PVC transmission lines under arterial roads leading away from Paris. Also useful in understanding the composition of Paris’ water system is the following table (Table 2.1) detailing the materials of water lines in the system sorted by date of pipe installation. This table shows the percentage of line length by material for each date range:
