CAPITAL IMPROVEMENTS PLAN Fiscal Years 2018-2027

McCreary County
Water District

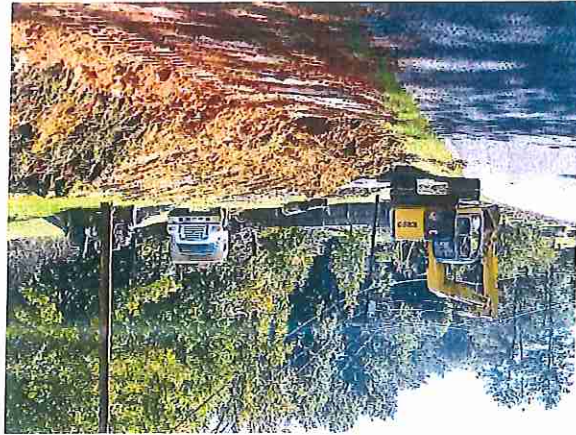
The Stearns to Smithtown waterline replacement project entails the construction of approximately 16,700 linear feet of 8-inch PVC, 5,100 linear feet of 4-inch PVC, and 1,600 linear feet of 2-inch PVC water main and appurtenances to replace an existing 6-inch and 4-inch water line to serve approximately 150 existing underserved customers.

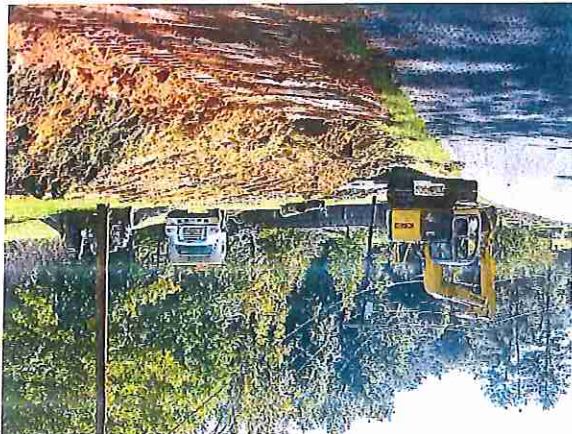
Marsh Creek Road to Hwy 92 waterline replacement project will consist of approximately 33,000 linear feet of 6-inch SDR 17 waterline to replace existing 2-inch and 4-inch waterline along Marsh Creek Road in Strunk, Kentucky. The project will begin near US 27 to the west and will end at KY 92 to the east. This project will improve reliability and residual pressure for approximately 450 underserved customers and one wholesale customer.

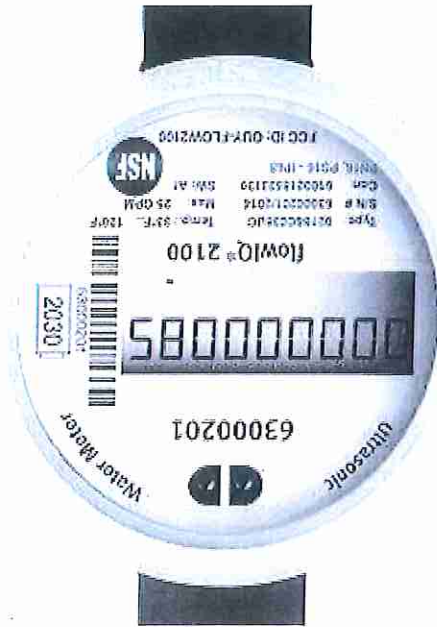
Automated Meter Reading (AMR) is a radio read meter reading system where we plan to replace approximately 6,200 water meters with radio read meters. This project includes the system setup with software and interfacing into our billing software program.

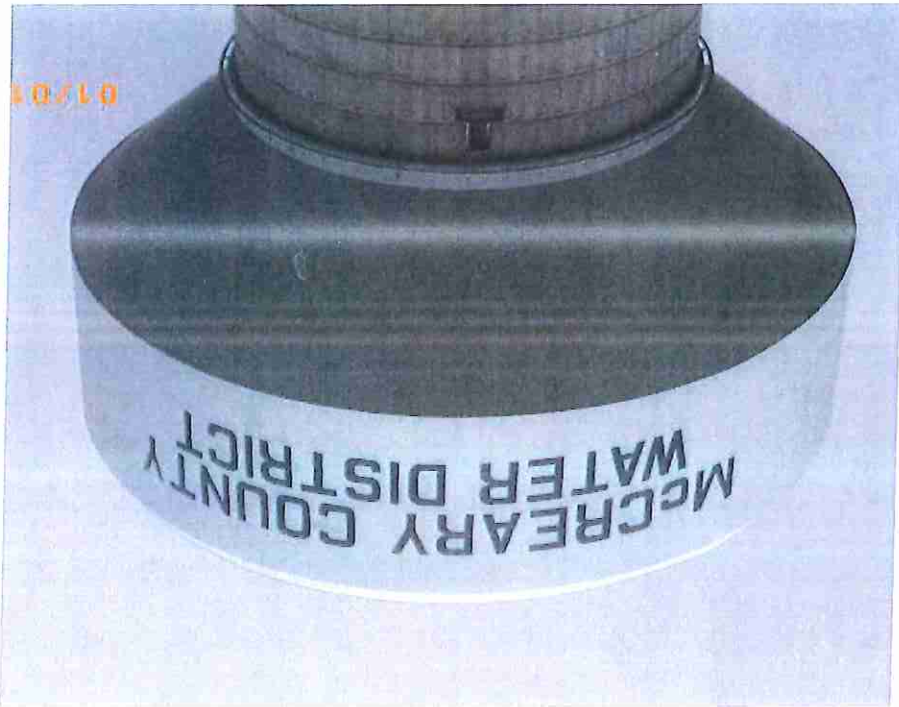
Water tank maintenance is another major issue. The first tank in need of maintenance is the 1,000,000 gallon Prison Tank. On April 24, 2017, Utility Service Co. Inc, conducted a Washout inspection of the tank and determined that the EXTERIOR of the tank was in FAIR condition. The protective coating system shows clear signs of deterioration indicative of a system near the end of its useful life. Proper tool cleaning, priming, and over-coating of the structure is recommended for the VERY NEAR future. It is also recommended to replace the existing vent which is in POOR condition and add two (2) new vents on the top of the tank.

The INTERIOR of the tank is in POOR condition with signs of delamination on the roof with flash rust on the support beams and coating of panels. Sediment staining is visual on sidewalls. Coating failure and spreading corrosion affects almost half of the interior structure. Conditions indicates the coating system is BEYOND its useful lifecycle. The interior ladder shows signs of corrosion and needs to be replaced. The target and float assembly is in POOR condition and needs to be replaced. Recommendations include blasting of interior and coating to be installed to protect the interior and prolong life of tank; mud valve needs replaced and reconnected to the drain line; and expansion joint on the riser pipe needs repaired and mud valve coupling replaced. Also, all corroded nuts and bolts need to be replaced with SST.

In summary, this water storage tank is in POOR condition. A MAJOR renovation and possible repairs should be planned as soon as feasible.

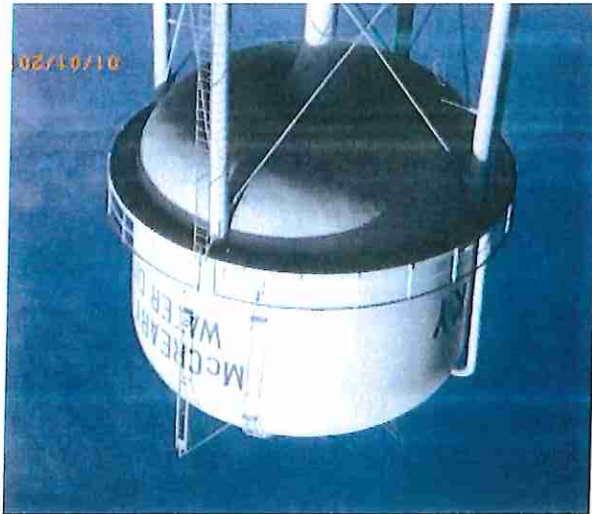
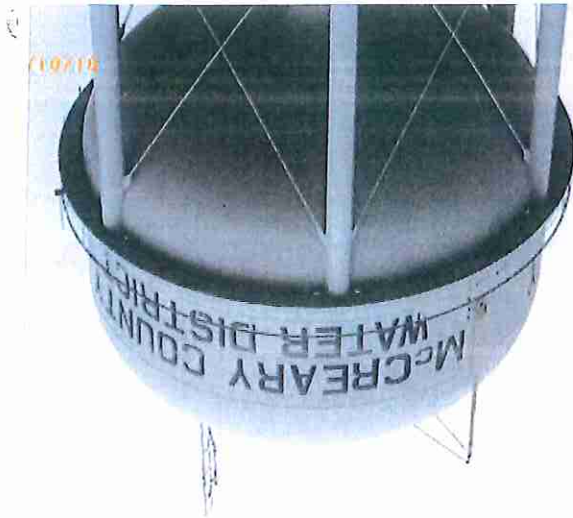
The second tank in need of maintenance is the 200,000 gallon Stearns Tank. On April 24, 2017, Utility Service Co. Inc, conducted a Washout inspection of the tank and determined that the EXTERIOR of the tank was in FAIR condition. The protective coating system shows clear signs of deterioration indicative of a system near the end of its useful life. Proper tool cleaning, priming, and over-coating of the structure is recommended for the very near future. It is also recommended to replace overflow zinc plated bolts with SST.

The INTERIOR of the tank is in POOR condition with signs of delamination on roof with flash rust on the support beams and coating of panels. Sediment staining is also visible on sidewalls. Coating failure and spreading corrosion affects almost half of the interior structure. Conditions indicates the coating system is beyond its useful lifecycle. Recommendations include blasting of interior and coating to be installed to protect the interior and prolong life of tank and repairing the float system.

In summary, this water storage tank is in POOR condition. A MAJOR renovation and possible repairs should be planned as soon as feasible.

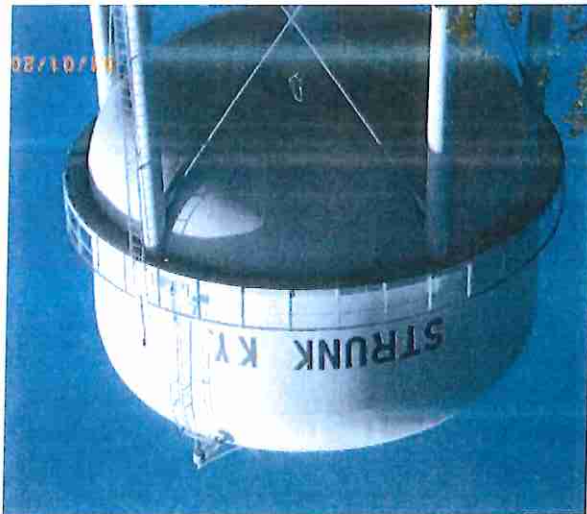
The Strunk tank is a 250,000 gallon elevated tank and is 4th on the list of needed maintenance. On April 24, 2017, Utility Service Co. Inc, conducted a Washout inspection of the tank and determined that the EXTERIOR of the tank was in FAIR condition. The protective coating system shows clear signs of deterioration indicative of a system near the end of its useful life. Proper tool cleaning, priming, and over-coating of the structure is recommended for the very near future.

The INTERIOR is in FAIR condition with signs of delamination on roof with flash rust on the support beams and coating of panels. Some sediment staining is visual on sidewalls. The protective coating system shows clear signs of deterioration indicative of a system near the end of its useful life. Proper tool cleaning, priming and over-coating of the structure is recommended for the very near future. Recommendations include tool blast and prime interior corroded areas, removing cathodic protection, and replacing the tide-flex mixing system.

In summary, this water storage tank is in FAIR condition.

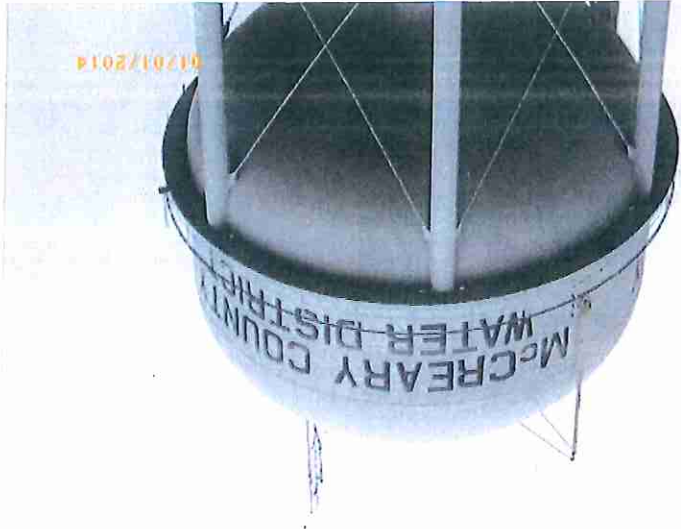
The fifth tank in need of maintenance is the Wolf Ridge tank. This tank holds 100,000 gallons.

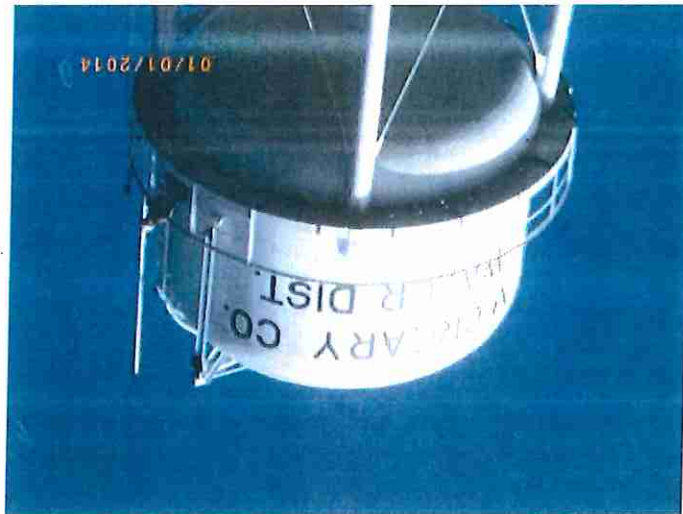
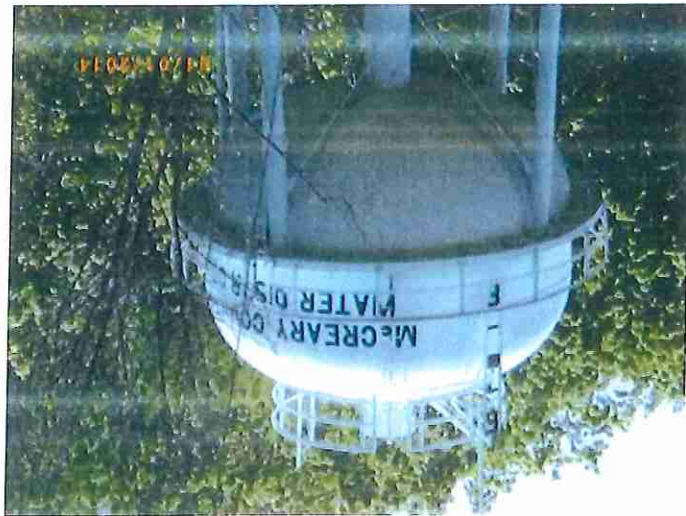
Number 8 on the tank repair list is the 50,000 gallon West 92 storage vessel. On April 24, 2017, Utility Service Co., Inc conducted a Washout inspection of the elevated tank and deemed the EXTERIOR of the tank was in GOOD condition. The protective coating system has random cosmetic deficiencies with signs of normal weathering and color fading. The exterior does not need over-coating at this time but some minor maintenance may be needed in the near future. It is only recommended that we power wash the exterior of the tank to extend the coating life. The INTERIOR is in FAIR condition with signs of delamination on roof with flash rust on the support beams and coating of panels. Some sediment staining is visual on sidewalls. The protective coating system shows clear signs of deterioration indicative of a system near the end of its useful life. Proper tool cleaning, priming, and over-coating of the structure is recommended for the very near future.

In summary, this water tank is in FAIR condition.
